**Flood Control Project Maintenance
Levee Inspections**

Fall 2016 Levee Maintenance Deficiency Summary Report

Sacramento River Basin

Reclamation District No. 1001 Nicolaus

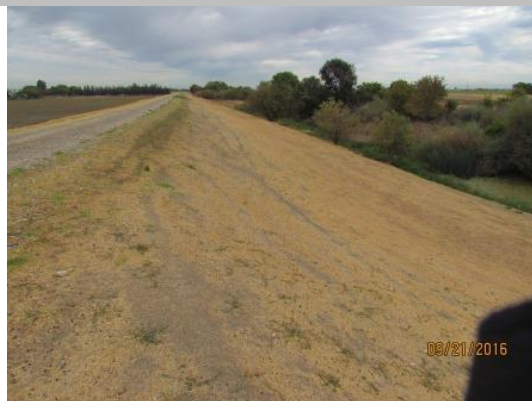
Photo 1 of 1 : FA_2016_RD1001_40_16_20160923_00038.jpg

LM Start	0.00	Rating **	A	Issue No.	16
LM End	4.73	Issue Type +	Ma	Location *	LS
Category	Earthen Levee			GPS Latitude/Longitude	
				Start	End
Item	Vegetation			38.831088 °	38.896359 °
				-121.529762 °	-121.520372 °
DWR ID	DWR_RD1001_06_f_2016_16				
Comment Code					
V1 : Control annual grass and weeds on the levee slopes and easements.					
Inspector Comment					
The Levee has no unwanted vegetation blocking visibility or access; vegetation is very well maintained.

View of maintained annual grasses, water side, looking upstream. Fall 2016.

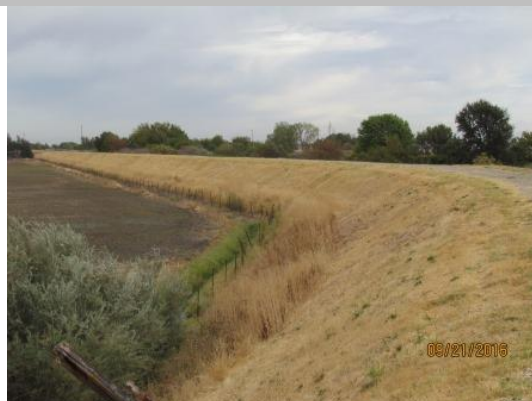
Photo 1 of 1 : FA_2016_RD1001_40_17_20160923_00036.jpg

LM Start	0.00	Rating **	A	Issue No.	17
LM End	4.73	Issue Type +	Ma	Location *	WS
Category	Earthen Levee			GPS Latitude/Longitude	
				Start	End
Item	Vegetation			38.831088 °	38.896359 °
				-121.529762 °	-121.520372 °
DWR ID	DWR_RD1001_06_f_2016_17				
Comment Code					
V1 : Control annual grass and weeds on the levee slopes and easements.					
Inspector Comment					
The Levee has no unwanted vegetation blocking visibility or access; vegetation is very well maintained.

View of maintained vegetation. Fall 2016.

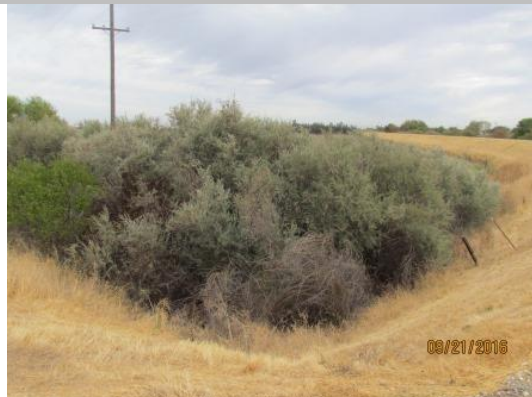
Photo 1 of 1 : FA_2016_RD1001_40_18_20160923_00035.jpg

LM Start	0.01	Rating **	M	Issue No.	18
LM End	0.01	Issue Type +	Ma	Location *	LS
Category	Earthen Levee			GPS Latitude/Longitude	
				Start	End
Item	Trim / Thin Trees			38.831192 °	38.831192 °
				-121.529580 °	-121.529580 °
DWR ID	DWR_RD1001_06_s_2016_18				
Comment Code					
T3 : Trim and thin trees to allow visibility of the ground and room to flood fight.					
Inspector Comment

View of trees that need to be trimmed for visibility on the landside looking upstream. Fall 2016.

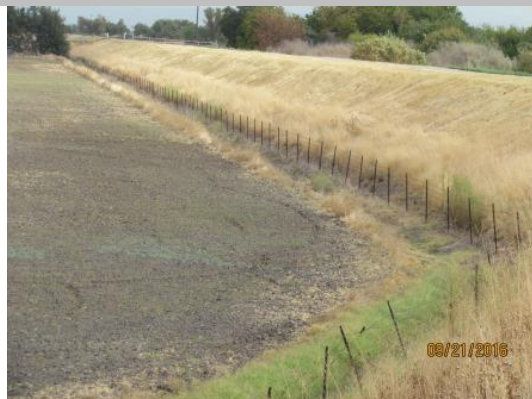
Photo 1 of 1 : FA_2016_RD1001_40_20_20160923_00037.jpg

LM Start	0.02	Rating **	M	Issue No.	20
LM End	0.43	Issue Type +	En	Location *	LS
Category	Earthen Levee			GPS Latitude/Longitude	
				Start	End
Item	Encroachments			38.831243 °	38.836832 °
				-121.529519 °	-121.526810 °
DWR ID	DWR_RD1001_06_f_2016_20				
Comment Code					
FE : Fence					
Inspector Comment					
Fence along the landside levee toe.

View of fence along the landside levee toe looking upstream. Fall 2016.

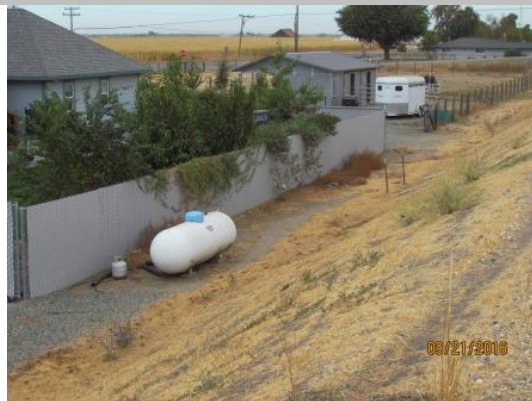
Photo 1 of 1 : FA_2016_RD1001_40_46_20160923_00039.jpg

LM Start	0.95	Rating **	M	Issue No.	46
LM End	0.95	Issue Type +	En	Location *	LS
Category	Earthen Levee			GPS Latitude/Longitude	
				Start	End
Item	Encroachments			38.844109 °	38.844109 °
				-121.524375 °	-121.524375 °
DWR ID	DWR_RD1001_06_s_2012_46				
Comment Code					
TA : Tank					
Inspector Comment

View of a propane tank that is within the landside easement of the levee.
Fall 2016.

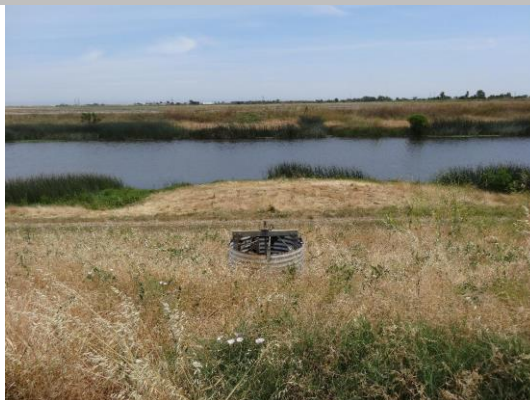
Photo 1 of 2 : UCIP_FA_2016_14244_23467.jpg

LM Start	1.72	Rating **	M	Issue No.	50
LM End	1.72	Issue Type +	En	Location *	LS
Category	Supplemental			GPS Latitude/Longitude	
				Start	End
Item	DWR UCIP Field Study			38.855186 °	38.855186 °
				-121.524895 °	-121.524895 °
DWR ID					
Comment Code					
Inspector Comment					
FS_ID:14244					
DS_ID:22617					
EP_NO: N/A					
Repair Type: Non-Urgent					
Crossing Status: Found					
UCIP Comments: - visible damage to pipe on opening at inlet due to high corrosion.- video inspection recommended.					
FIELD_STRUCT_DESC: 36-inch corrugated-metal drainage pipe through the levee, 12.5 feet below the crown, slide gate in a 48-inch corrugated-metal pipe riser on the waterward slope, concrete headwall at the landward toe, the pipe crosses under the channel.					
FS Date: 5/15/2013

WS- slide gate in CMP riser on levee slope.

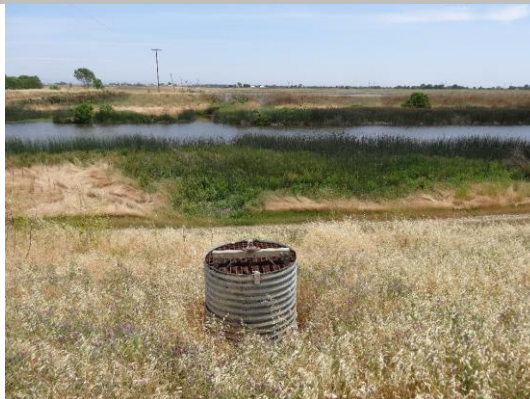
Photo 1 of 2 : UCIP_FA_2016_14223_23445.jpg

LM Start	2.03	Rating **	M	Issue No.	49
LM End	2.03	Issue Type +	En	Location *	LS
Category	Supplemental			GPS Latitude/Longitude	
				Start	End
Item	DWR UCIP Field Study			38.859601 °	38.859601 °
				-121.524885 °	-121.524885 °
DWR ID					
Comment Code					
Inspector Comment					
FS_ID:14223					
DS_ID:22616					
EP_NO: N/A					
Repair Type: Non-Urgent					
Crossing Status: Found					
UCIP Comments: - pipe buried/submerged on LS- needs cleaning of LS pipe end opening.					
FIELD_STRUCT_DESC: 24-inch corrugated-metal drainage pipe through the levee, 15.5 feet below the crown, slide gate in a 36-inch corrugated-metal pipe riser on the waterward slope, concrete headwall at the landward toe, the pipe crosses under the channel					
FS Date: 5/15/2013

WS- slide gate in CMP riser on levee slope.

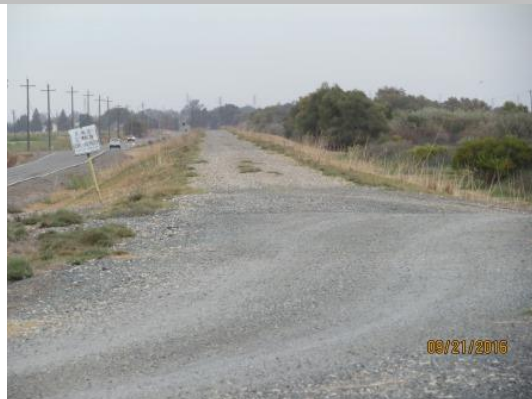
Photo 1 of 1 : FA_2016_RD1001_40_8_20160923_00041.jpg

LM Start	2.05	Rating **	A/W	Issue No.	8
LM End	2.05	Issue Type +	Ma	Location *	CR
Category	Earthen Levee			GPS Latitude/Longitude	
				Start	End
Item	Crown Surface / Depressions / Rutting			38.860002 °	38.860002 °
				-121.524873 °	-121.524873 °
DWR ID	DWR_RD1001_06_s_2012_8				
Comment Code					
C2 : Repair depressions or ruts in the crown or slope.					
Inspector Comment					
Crown where there is cross traffic. Monitor this area and fix as needed.

View of crown where there is cross traffic looking upstream. Monitor this area and fix as needed.

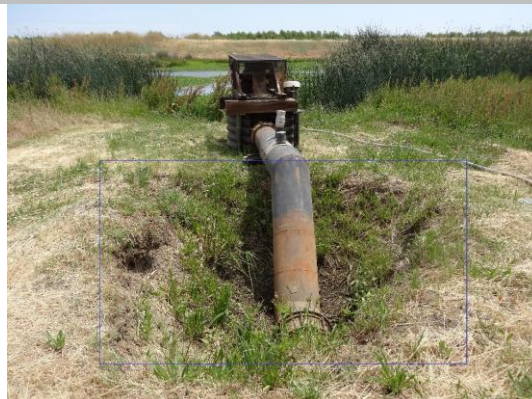
Photo 2 of 2 : UCIP_FA_2016_50692_23429.jpg

Comment Code					
Inspector Comment					
FS_ID:50692 DS_ID:22622 EP_NO: 12208 Repair Type: Urgent Crossing Status: Found UCIP Comments: 07/13/2016 Depression on WS berm has been backfilled, but the cause of the erosion was not addressed to my knowledge. As such, pipe integrity problem may still exist. Vegetation growth surrounds pipe on WS berm, in strike contrast to dry grass away from pipe alignment. This could be due to channel draining toward the pipe, or an indication of pipe leakage. (K. Fazel - UCIP)05/15/2013:- large pit at pipe daylight on WS berm, may be due to pipe leakage.- siphon breaker on LS shoulder not found. (P. Amatya - DWR) FIELD_STRUCT_DESC: 16-inch steel irrigation pipe through the levee, 3 feet below the crown. 16-inch low-lift pump in the channel with a 1-inch electrical line also penetrating the levee to the power pole off the landside (LS) toe. 36-inch corrugated metal pipe (CMP) riser on the bank. Vent on the LS shoulder. Siphon breaker/vent on the apex of the pipe near the WS pump. Standpipe off the LS toe. Pipe used seasonally only in the absense of groundwater, as per district president Joe Henderson. (Permit No. 12208, 1977 - Cuguet). [Additional Reference(s): DWR Levee Log, 1993] FS Date: 7/13/2016

WS- large depression on levee berm

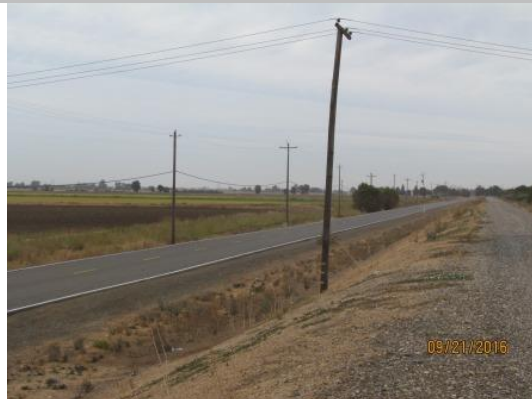
Photo 1 of 1 : FA_2016_RD1001_40_21_20160923_00044.jpg

LM Start	3.03	Rating **	A	Issue No.	21
LM End	3.03	Issue Type +	En	Location *	LS
Category	Earthen Levee			GPS Latitude/Longitude	
				Start	End
Item	Encroachments			38.874211 °	38.874211 °
				-121.524824 °	-121.524824 °
DWR ID	DWR_RD1001_06_f_2016_21				
Comment Code					
PO : Pole					
Inspector Comment

View of pole on landside levee slope looking upstream. Fall 2016.

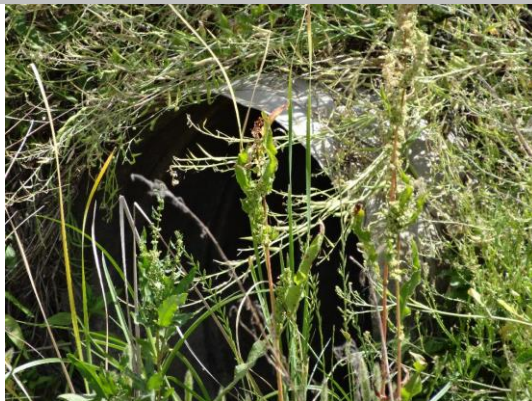
Photo 1 of 2 : UCIP_FA_2016_14167_23396.jpg

LM Start	3.28	Rating **	M	Issue No.	53
LM End	3.28	Issue Type +	En	Location *	LS
Category	Supplemental			GPS Latitude/Longitude	
				Start	End
Item	DWR UCIP Field Study			38.877706 °	38.877706 °
				-121.524787 °	-121.524787 °
DWR ID					
Comment Code					
Inspector Comment					
FS_ID:14167					
DS_ID:22630					
EP_NO: N/A					
Repair Type: Non-Urgent					
Crossing Status: Found					
UCIP Comments: - pipe opens in irrigation ditch on landside.-					
vegetation cleaning on LS pipe opening.					
FIELD_STRUCT_DESC: 24-inch corrugated-metal drainage pipe					
through the levee, 12.0 feet below the crown, slide gate in a 36-inch					
corrugated-metal pipe riser on the waterward slope, concrete headwall					
at the landward toe, the pipe crosses under the channel					
FS Date: 5/15/2013

LS- vegetation on CMP end.

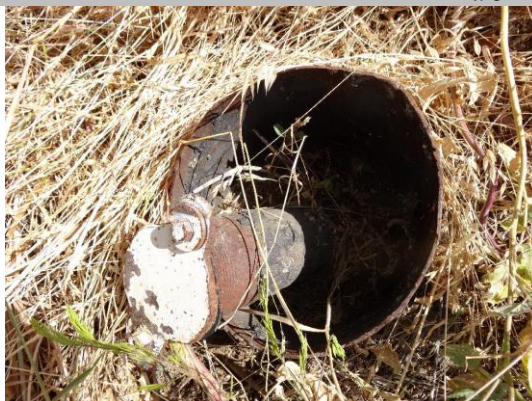
Photo 1 of 2 : UCIP_FA_2016_13523_22121.jpg

FS_ID:13523
DS_ID:22619
EP_NO: N/A
Repair Type: Non-Urgent
Crossing Status: Found
UCIP Comments: - needs filling/plugging gap between 4-inch and 10-inch pipes.
FIELD_STRUCT_DESC: 1 of 2: A capped 4-inch steel pipe sleeved through a 10-inch steel pipe, located just off the top of the slope on waterside of the levee.
FS Date: 5/15/2013

WS- a 4-inch steel pipe sleeved through 10-inch steel pipe.

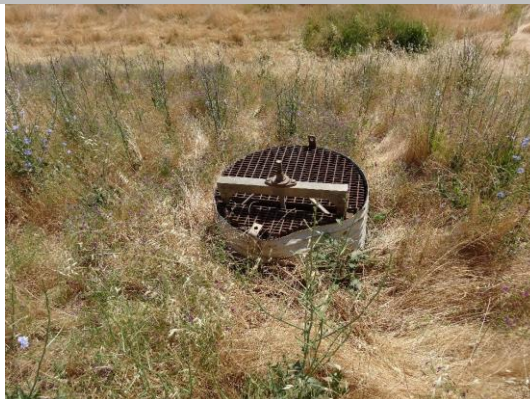
Photo 1 of 2 : UCIP_FA_2016_13509_22086.jpg

LM Start	3.59	Rating **	M	Issue No.	51
LM End	3.59	Issue Type +	En	Location *	LS
Category	Supplemental			GPS Latitude/Longitude	
				Start	End
Item	DWR UCIP Field Study			38.882247 °	38.882247 °
				-121.524762 °	-121.524762 °
DWR ID					
Comment Code					
Inspector Comment					
FS_ID:13509					
DS_ID:22631					
EP_NO: N/A					
Repair Type: Non-Urgent					
Crossing Status: Found					
UCIP Comments: Only a small section of head wall visible, almost buried.					
FIELD_STRUCT_DESC: 24-inch corrugated-metal drainage pipe through the levee, 12.0 feet below the crown, slide gate in a 36-inch corrugated-metal pipe riser on the waterward slope, concrete headwall at the landward toe, the pipe crosses under the channel					
FS Date: 5/15/2013

WS- fixed slide gate in CMP riser on levee slope.

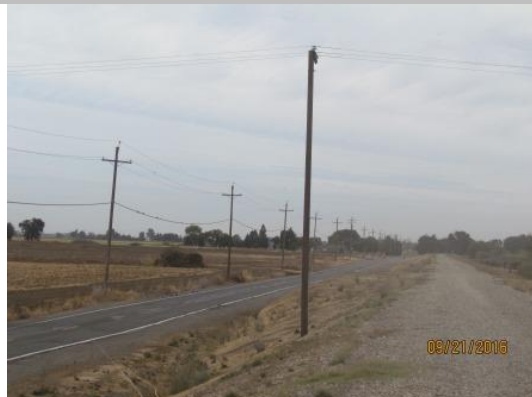
Photo 1 of 1 : FA_2016_RD1001_40_48_20160923_00045.jpg

LM Start	3.70	Rating **	A	Issue No.	48
LM End	3.70	Issue Type +	En	Location *	LS
Category	Earthen Levee			GPS Latitude/Longitude	
				Start	End
Item	Encroachments			38.883887 °	38.883887 °
				-121.524767 °	-121.524767 °
DWR ID	DWR_RD1001_06_s_2012_48				
Comment Code					
PO : Pole					
Inspector Comment

View of pole on landside levee slope looking upstream. Fall 2016.

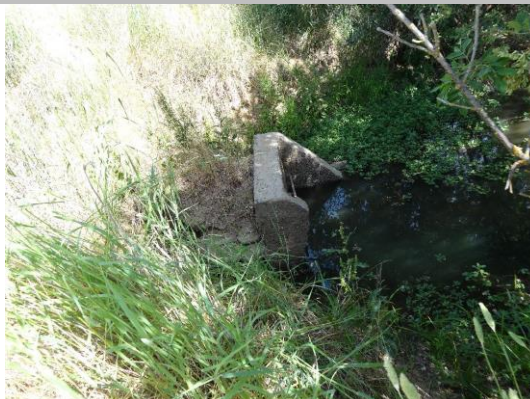
Photo 2 of 2 : UCIP_FA_2016_41724_22033.jpg

LM Start	4.36	Rating **	M	Issue No.	54 (cont)	
LM End	4.36	Issue Type +	En	Location *	CR	
Category	Supplemental			GPS Latitude/Longitude		
				Start	End	
Item	DWR UCIP Field Study			38.893448 °	38.893448 °	
				-121.524719 °	-121.524719 °	
DWR ID						
Comment Code						
Inspector Comment						
FS_ID:41724						
DS_ID:22618						
EP_NO: N/A						
Repair Type: Non-Urgent						
Crossing Status: Found						
UCIP Comments: - damaged head/wing wall in inlet structure.						
FIELD_STRUCT_DESC: 30-inch corrugated-metal gravity irrigation pipe through the levee, 15.9 feet below the crown, slide gate in a 36-inch corrugated-metal pipe riser on the waterward slope, the pipe discharges into a large irrigation ditch on the west side of Pacific Avenue (Joplin and South Sutter Water District)						
FS Date: 5/15/2013

WS- inlet wing wall with trashrack

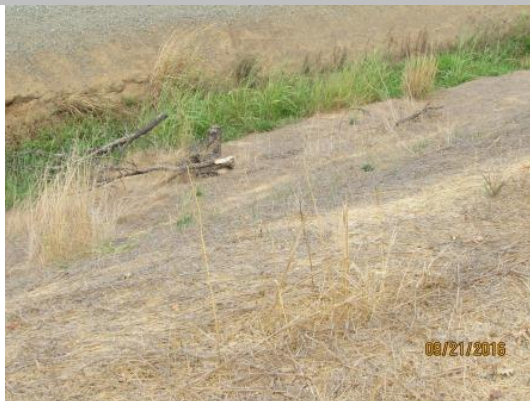
Photo 1 of 1 : FA_2016_RD1001_40_22_20160923_00046.jpg

LM Start	4.38	Rating **	N	Issue No.	22
LM End	4.38	Issue Type +	Ma	Location *	LS
Category	Earthen Levee			GPS Latitude/Longitude	
				Start	End
Item	Trim / Thin Trees			38.893728 °	38.893728 °
				-121.524715 °	-121.524715 °
DWR ID	DWR_RD1001_06_f_2016_22				
Comment Code					
T5 : Tree stumps.					
Inspector Comment					
A stump at the landside levee toe.

View of a stump at the landside levee toe. Fall 2016.
